HISTORIC AMERICAN BUILDINGS SURVEY
INVENTORY

2. NAME *Orrin Thompson Mansion*

DATE OR PERIOD *1832*
STYLE *Greek Revival*
ARCHITECT
BUILDER *Orrin Thompson*

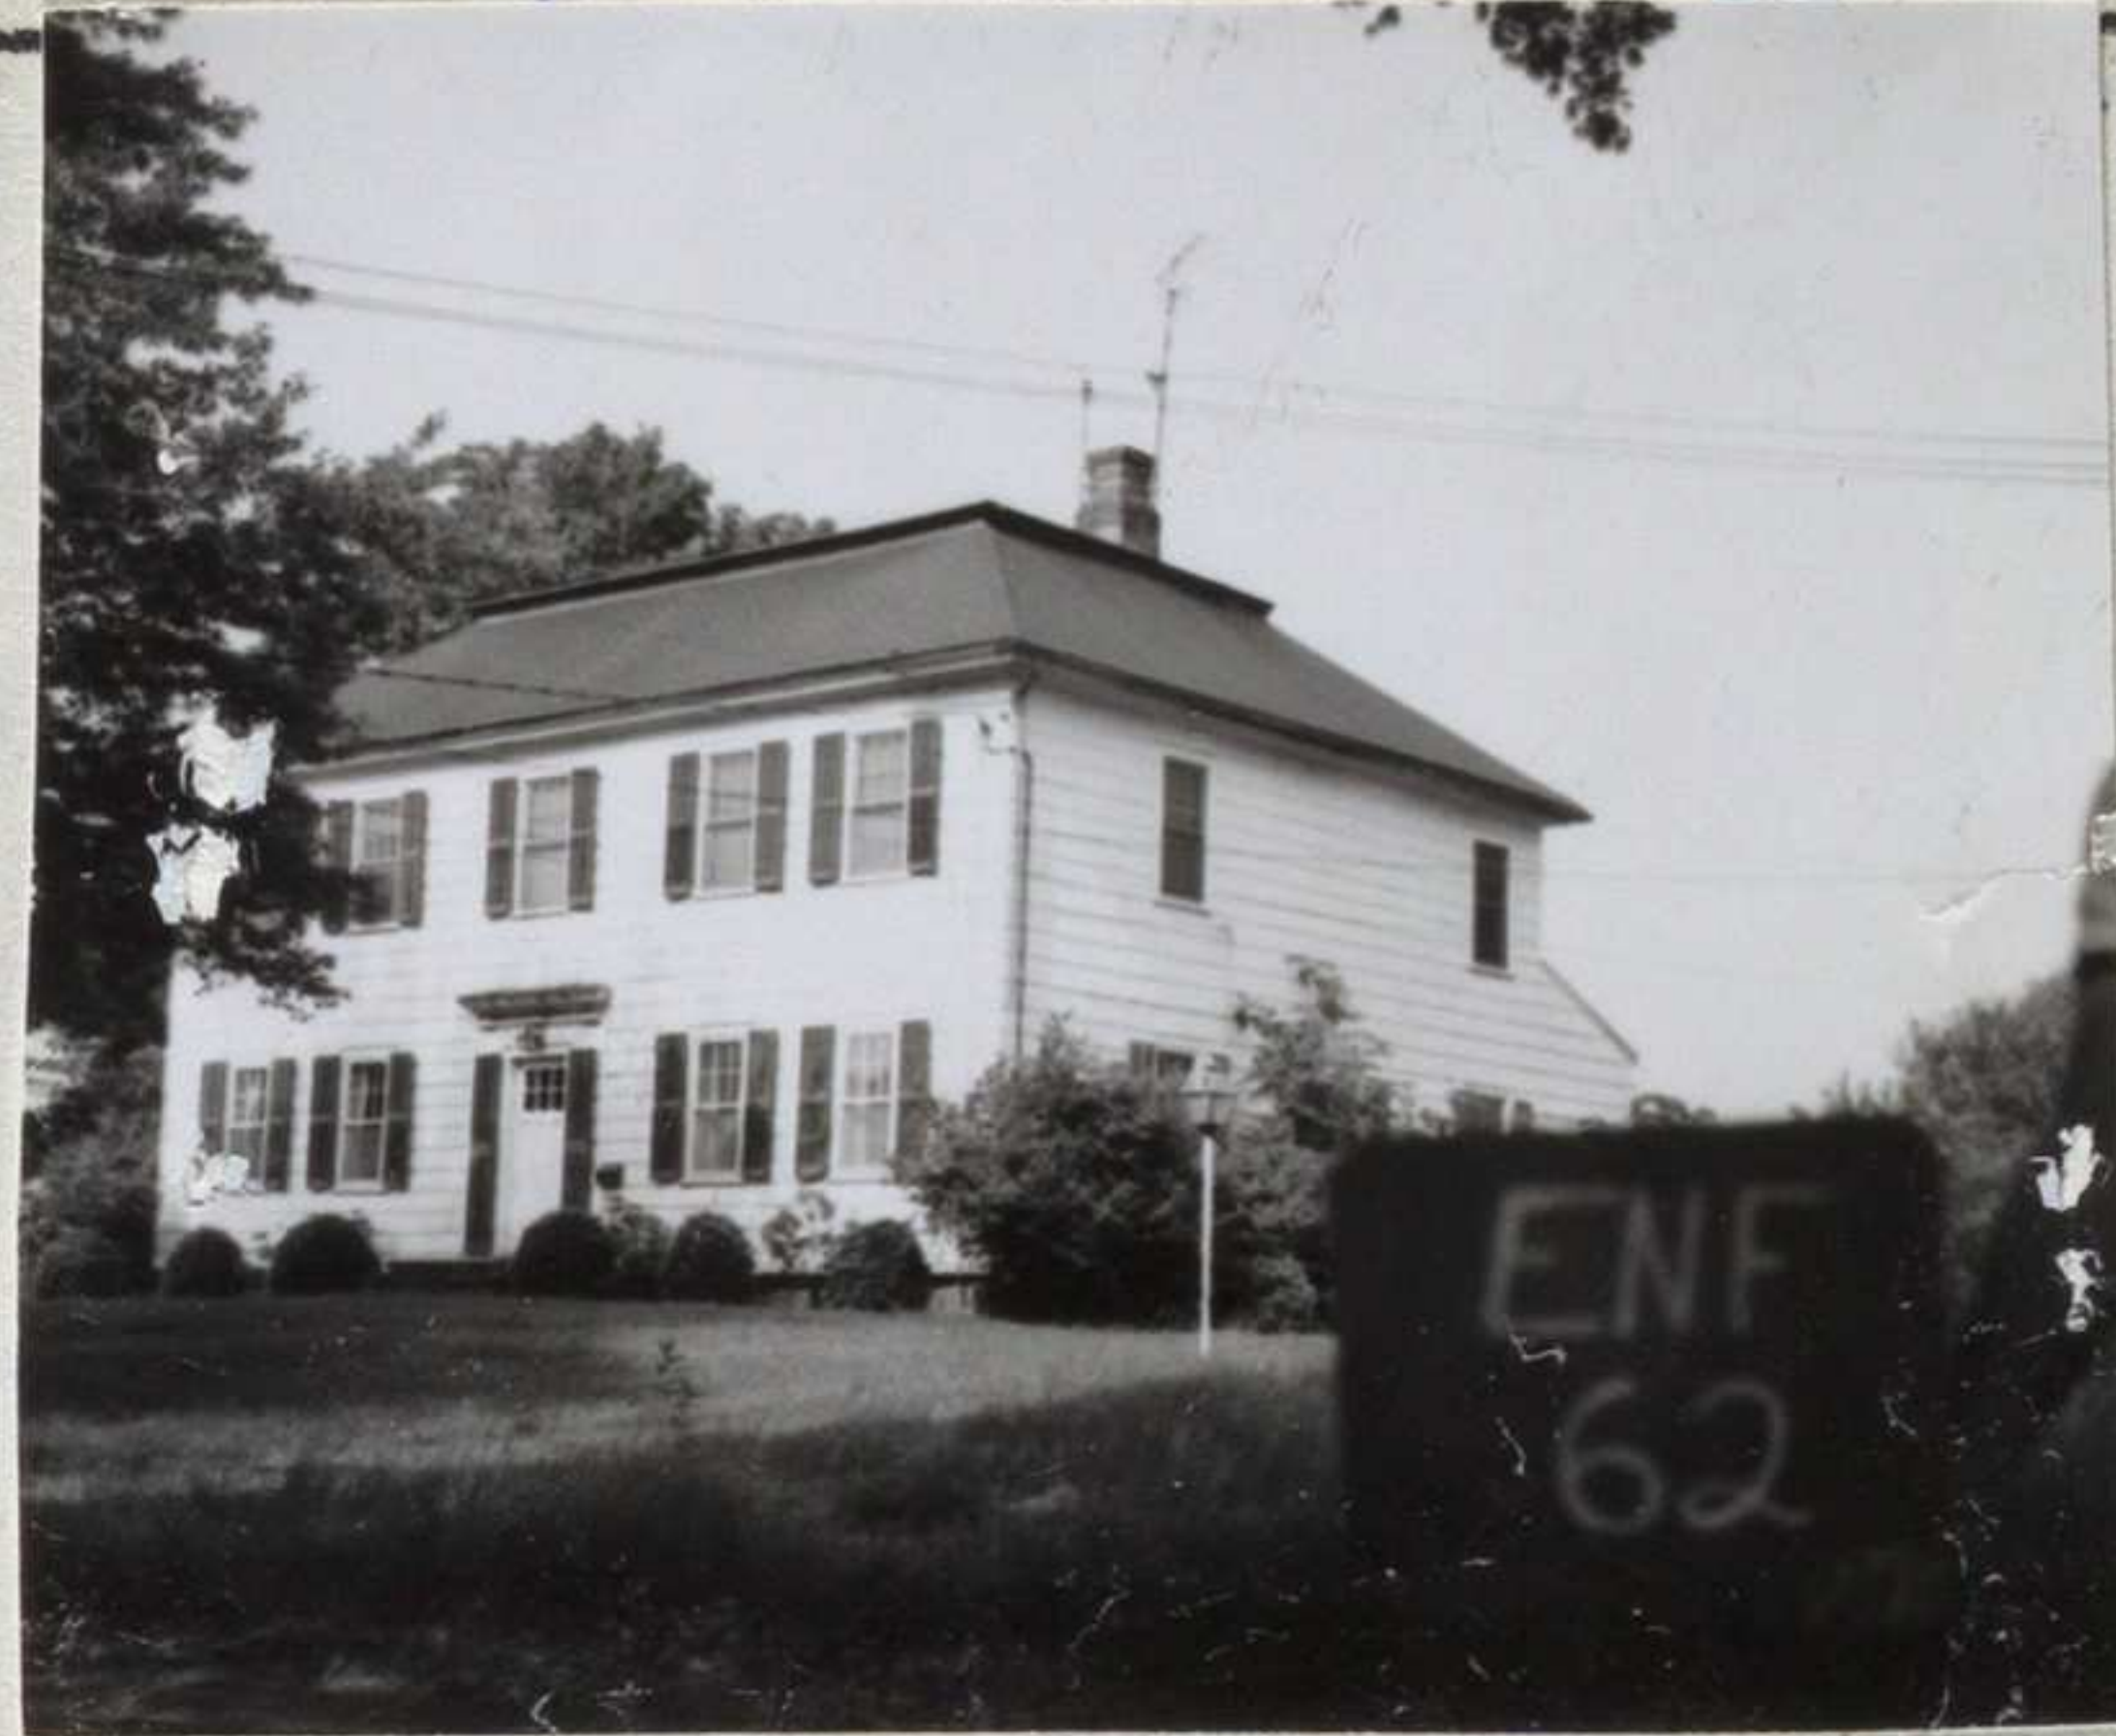
7. PHOTOGRAPH *Enf 62*

Ephraim Pease built each of his daughters a fine house as a wedding present. This one was built for his second daughter Nancy on her marriage to Augustus Diggins in 1772. Recently the house has been moved 50 yards south of its original site to make way for Route 190. The Tho? Hale was not so lucky. This house is a fascinating example of its period. The five bay facade is now on a brick foundation. The windows are 6/6 pane windows. The roof is the only one of its type in the area, being a double step or gambrel hip roof. The doorway is blatantly non original but the original doorway held two door ways. The entablature is all that remains of what must have ^{over}

Endangered *No.* Interior *fair?* Exterior *fair*

been a fully monumental door
way of the early Connect-
icut type. Would that it
was intact.

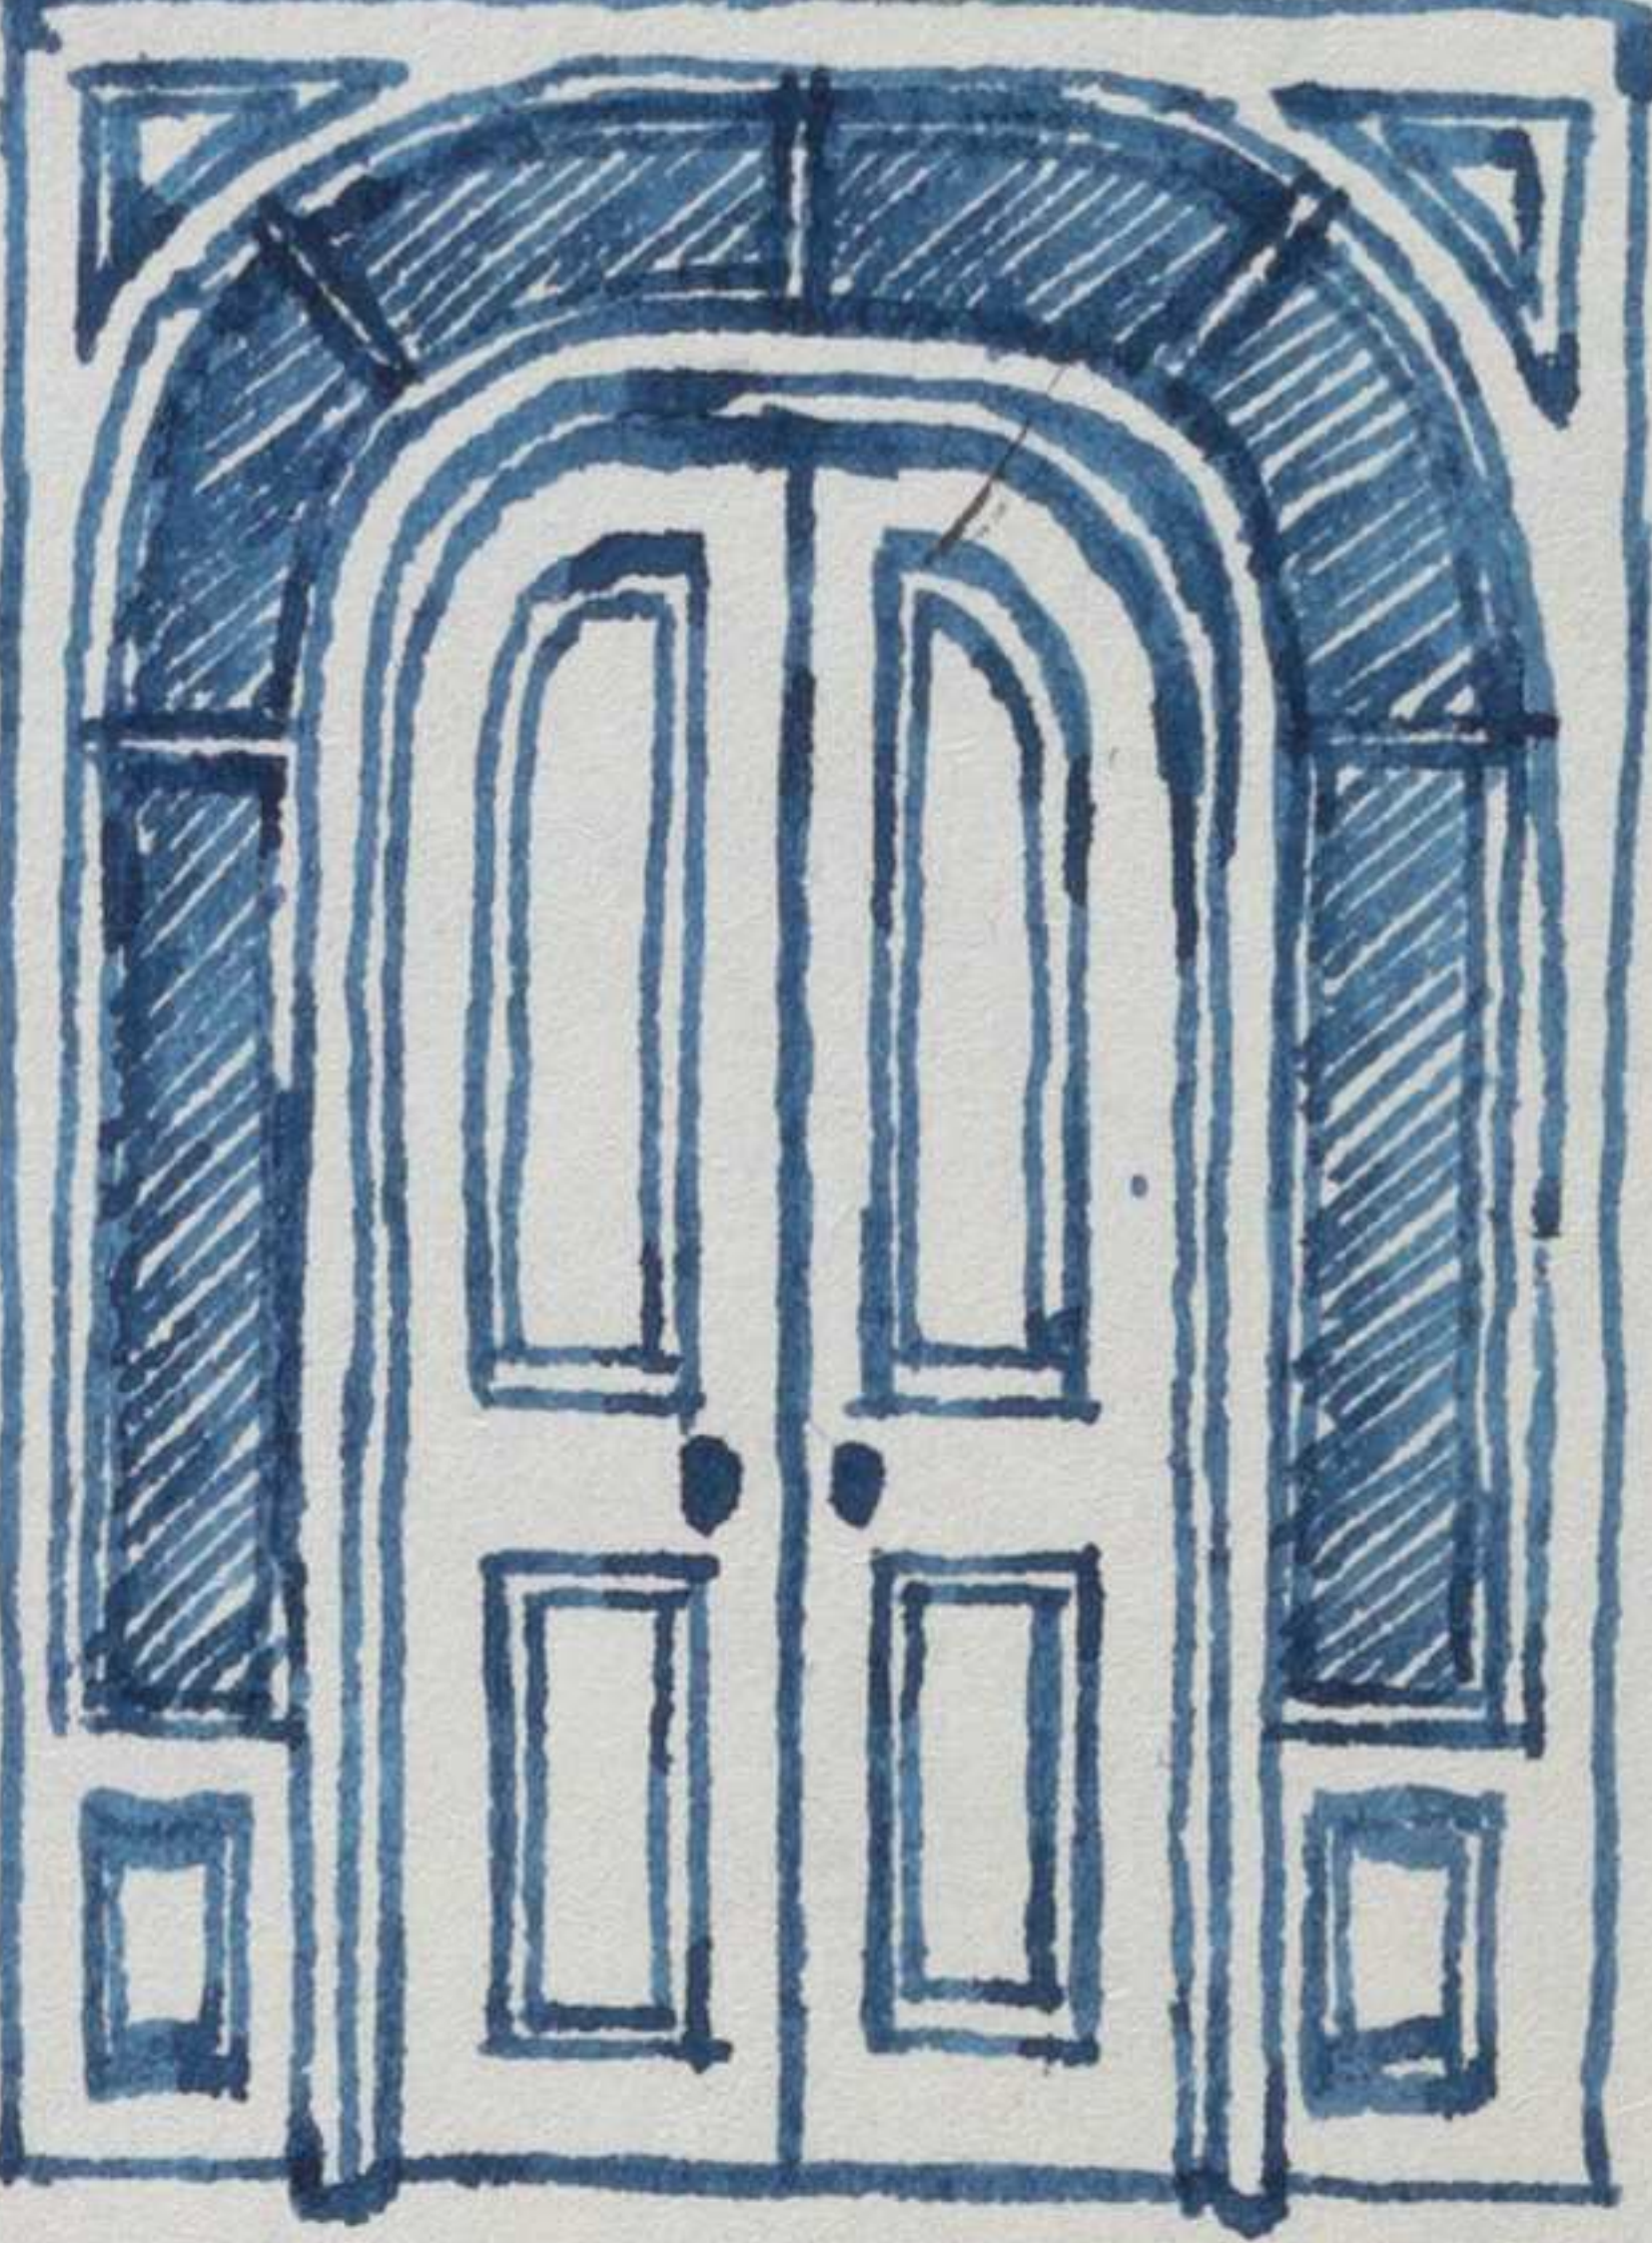
<p><i>doorways</i></p> </div> </div>

<p><i>pilaster</i></p> </div> <div style="width: 50%;"> <p><i>The windows are 6/6. The doorway is quite similar and probably built by the same carpenter as House #34. The corners are ornamented with interesting paneled pilasters and there are two end chimneys. The date 1806 is surprising since most of the house's features are later.</i></p> </div> <div style="width: 20%;">

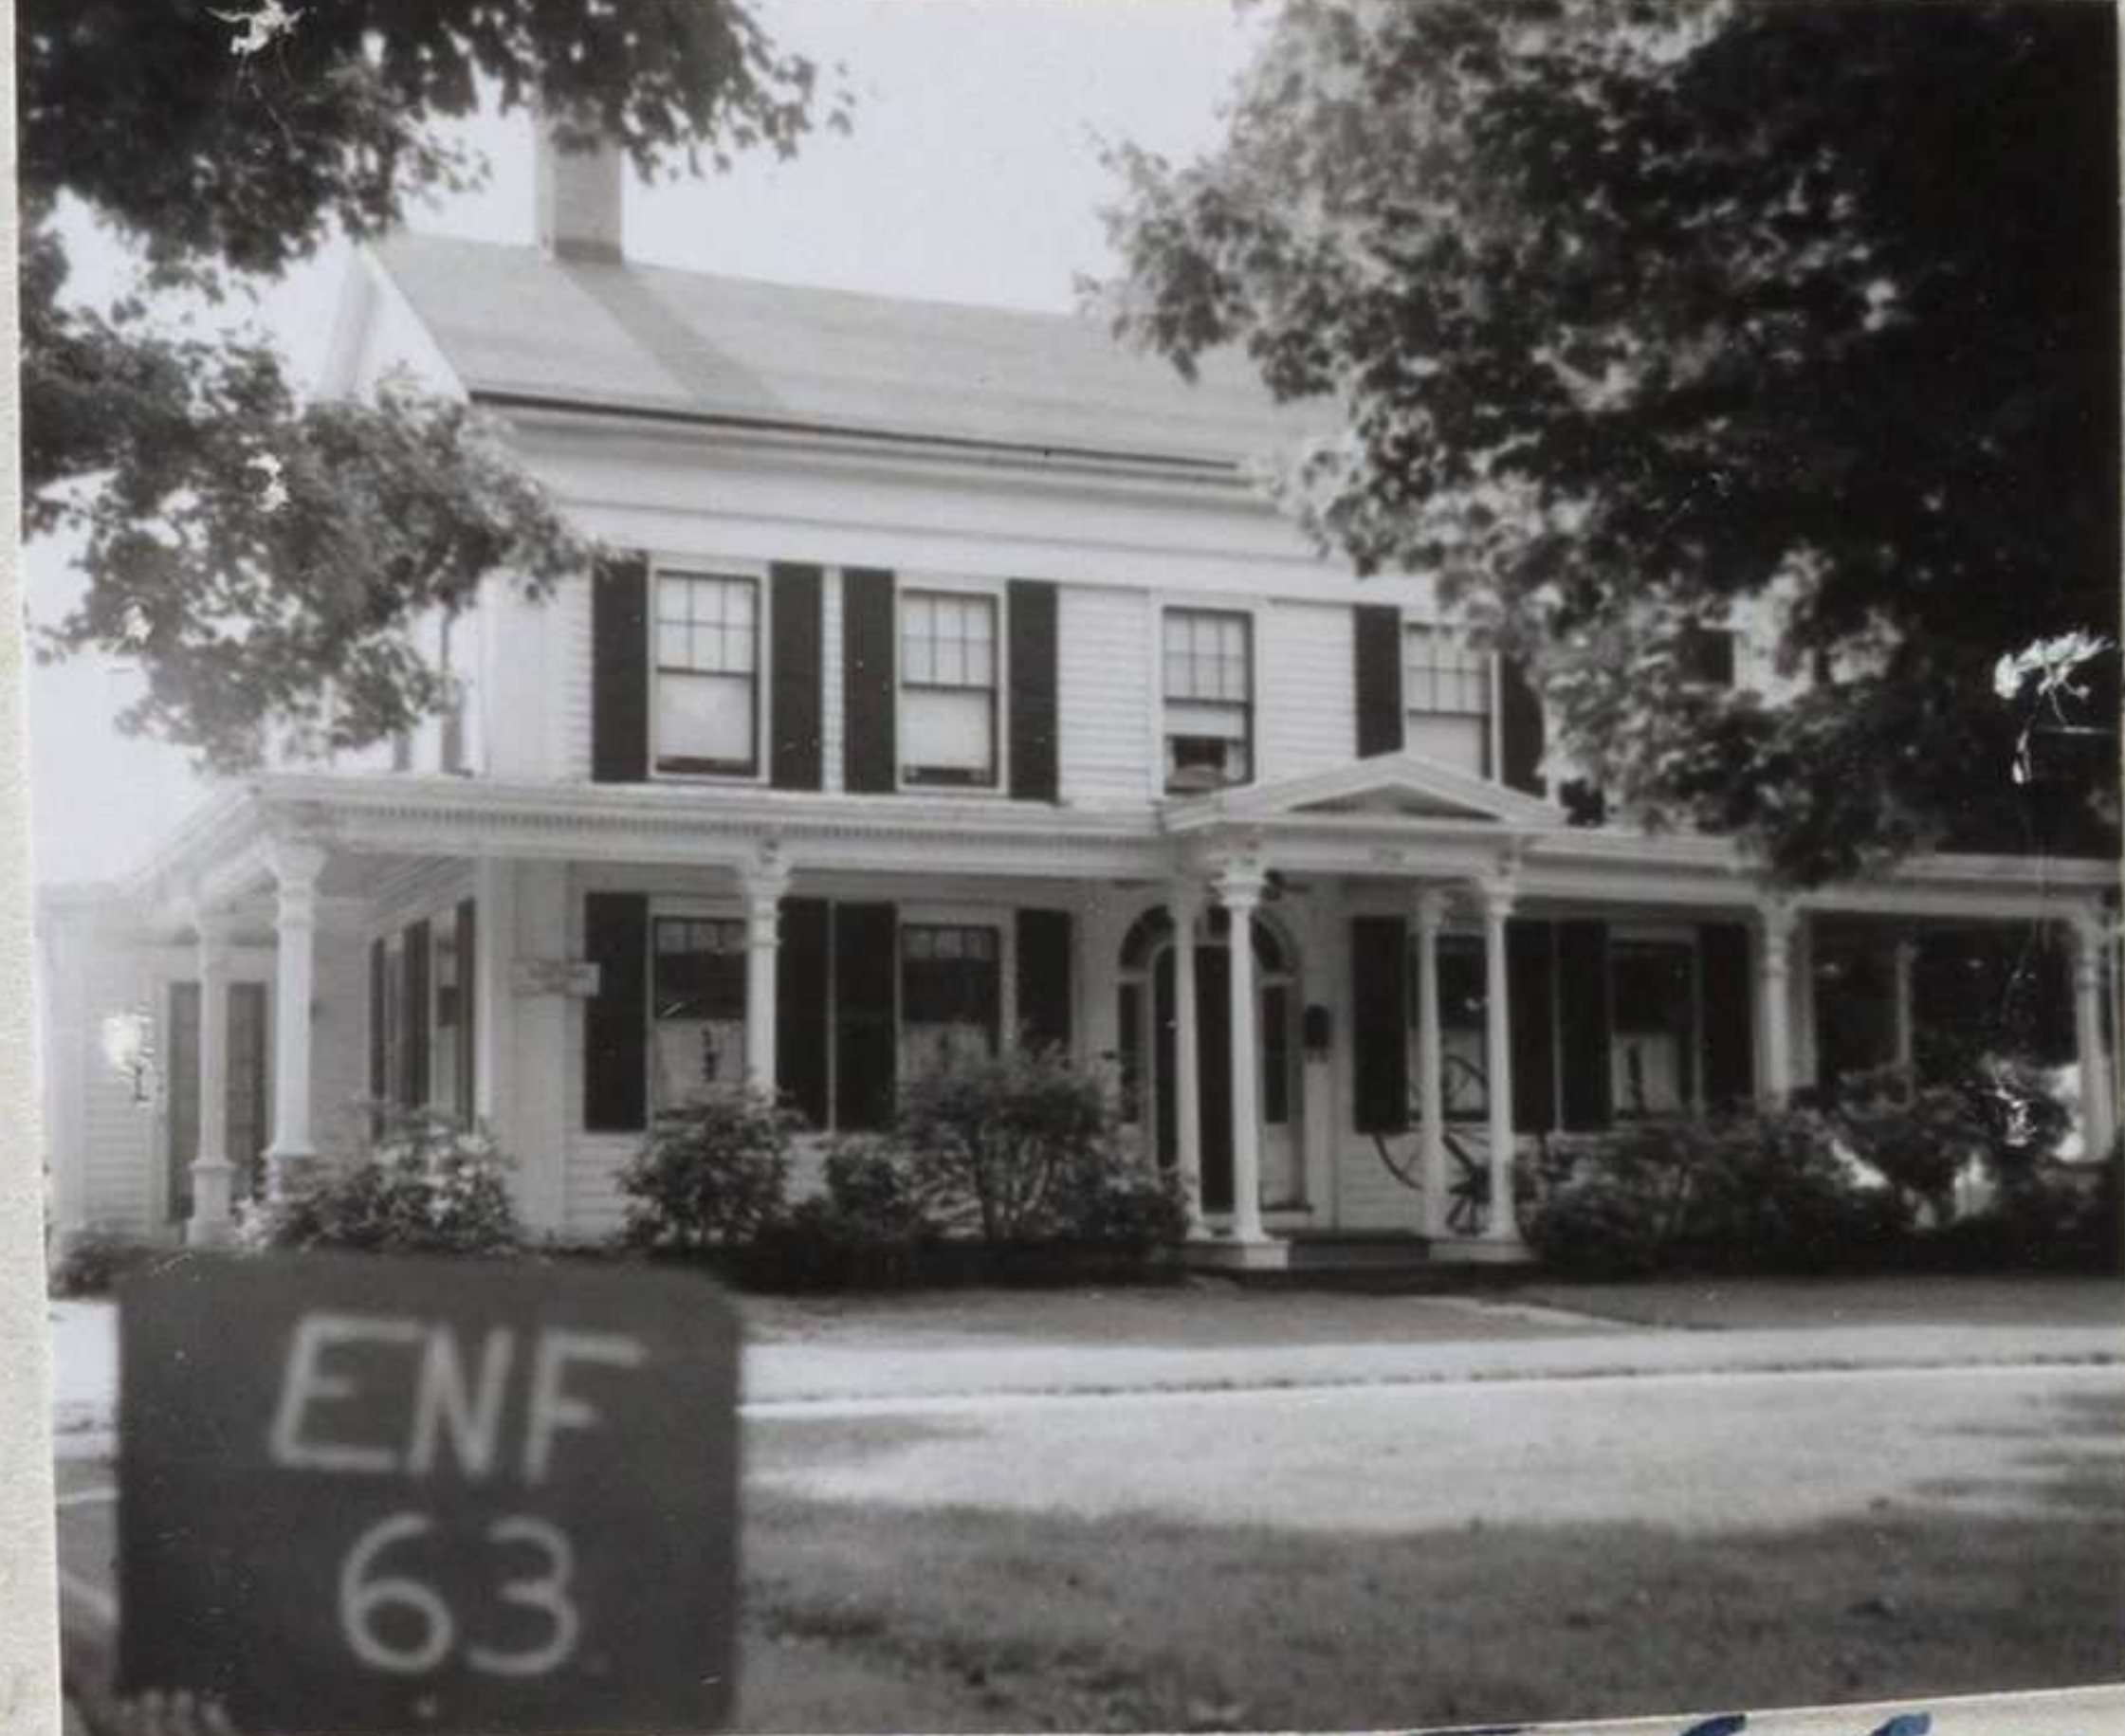
<p>7. PHOTOGRAPH <i>Enf 63</i></p> </div> </div>	
<p>8. PUBLISHED SOURCES (Author, Title, Pages) INTERVIEWS, RECORDS, PHOTOS, ETC.</p>	<p>9. NAME, ADDRESS AND TITLE OF RECORDER</p> <p><i>Elric J. Endersby</i> <i>Director of Buildings</i></p> <p>DATE OF RECORD <i>7/12/67</i></p>

<p>1. STATE <i>CT</i> COUNTY <i>Hartford</i> TOWN <i>Enfield</i> VICINITY STREET NO. <i>1209 Enfield Street</i></p> <p>ORIGINAL OWNER <i>Elias Terry</i> ORIGINAL USE <i>Residence</i> PRESENT OWNER <i>?</i> PRESENT USE <i>Residence</i> WALL CONSTRUCTION <i>clapboard</i> NO. OF STORIES <i>2</i></p>	<p>HISTORIC AMERICAN BUILDINGS SURVEY INVENTORY</p> <p>2. NAME <i>Elias Terry House</i></p> <p>DATE OR PERIOD <i>1806</i> STYLE <i>Greek Revival</i> ARCHITECT BUILDER <i>Elias Terry</i></p> <p>3. FOR LIBRARY OF CONGRESS USE</p>
<p>4. NOTABLE FEATURES, HISTORICAL SIGNIFICANCE AND DESCRIPTION</p> <p style="text-align: right;">OPEN TO PUBLIC <i>No</i></p> <p><i>This five bay house has a medium pitched roof with pediments of accentuated cornices, decorated with recessed triangular pediments.</i></p> <div style="display: flex; justify-content: space-between;"> <div style="width: 20%;">

<p>5. PHYSICAL CONDITION OF STRUCTURE Endangered <i>?</i> Interior <i>fair?</i> Exterior <i>good</i></p> <div style="display: flex; justify-content: space-between;"> <div style="width: 45%;">

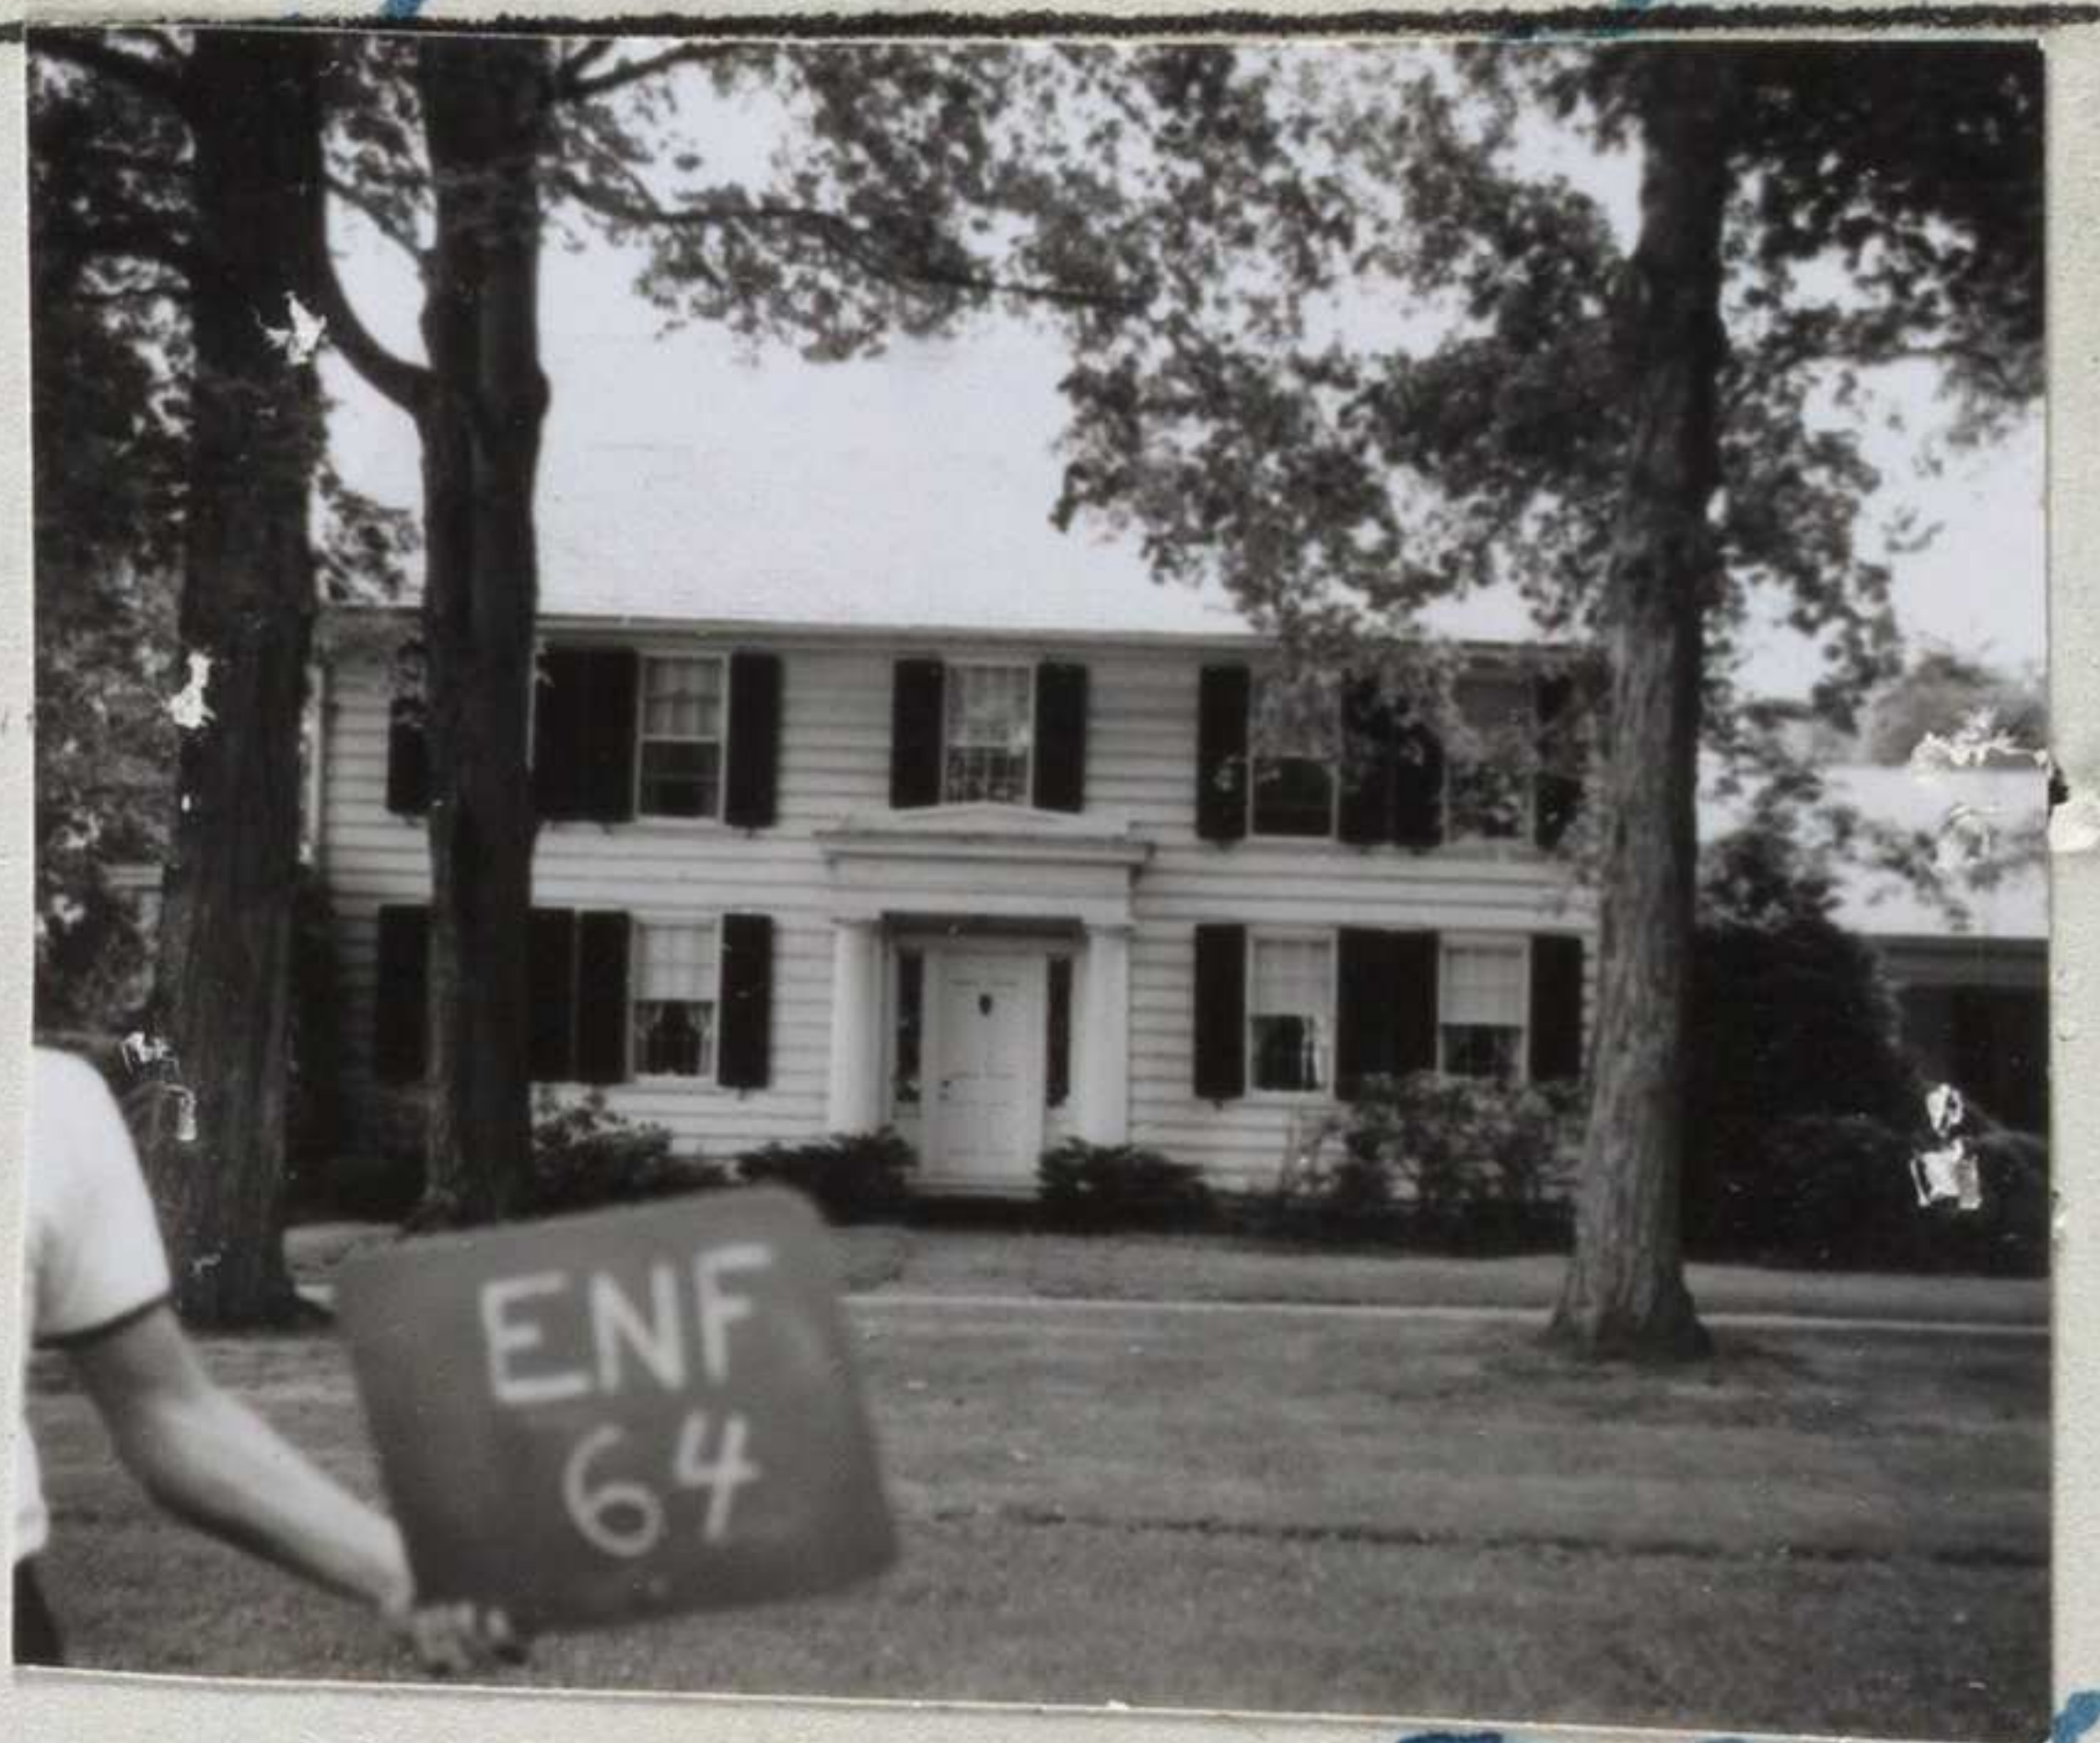
<p>1. STATE <i>CC</i> COUNTY <i>Hartford</i> TOWN <i>Enfield</i> VICINITY STREET NO. <i>1216 Enfield Street</i></p> <p>ORIGINAL OWNER? ORIGINAL USE <i>Residence</i> PRESENT OWNER? PRESENT USE <i>Residence</i> WALL CONSTRUCTION <i>clapboard</i> NO. OF STORIES <i>2</i></p>		<p>HISTORIC AMERICAN BUILDINGS SURVEY INVENTORY</p> <p>2. NAME</p> <p>DATE OR PERIOD <i>pre 1750</i> STYLE <i>Georgian with Greek additions</i> ARCHITECT BUILDER</p> <p>3. FOR LIBRARY OF CONGRESS USE</p>	
<p>4. NOTABLE FEATURES, HISTORICAL SIGNIFICANCE AND DESCRIPTION</p> <p>Built on a brownstone foundation this house has five bays and steep (40°) roof. There is only one 12/12 window left in the facade, that being over the central doorway. The others are 6/6. The house has the early feature of a central chimney. There is a fine added Greek Revival doorway. A fine Doric portico frames this doorway, with a fine pediment and the 1/4 modular Doric columns with out plinth blocks. To the north is a wing with other Doric columns. The house is roofed with slate.</p>

<p>OPEN TO PUBLIC <i>No</i></p> <p>5. PHYSICAL CONDITION OF STRUCTURE Endangered <i>No</i> Interior <i>good?</i> Exterior <i>good</i></p> <div>

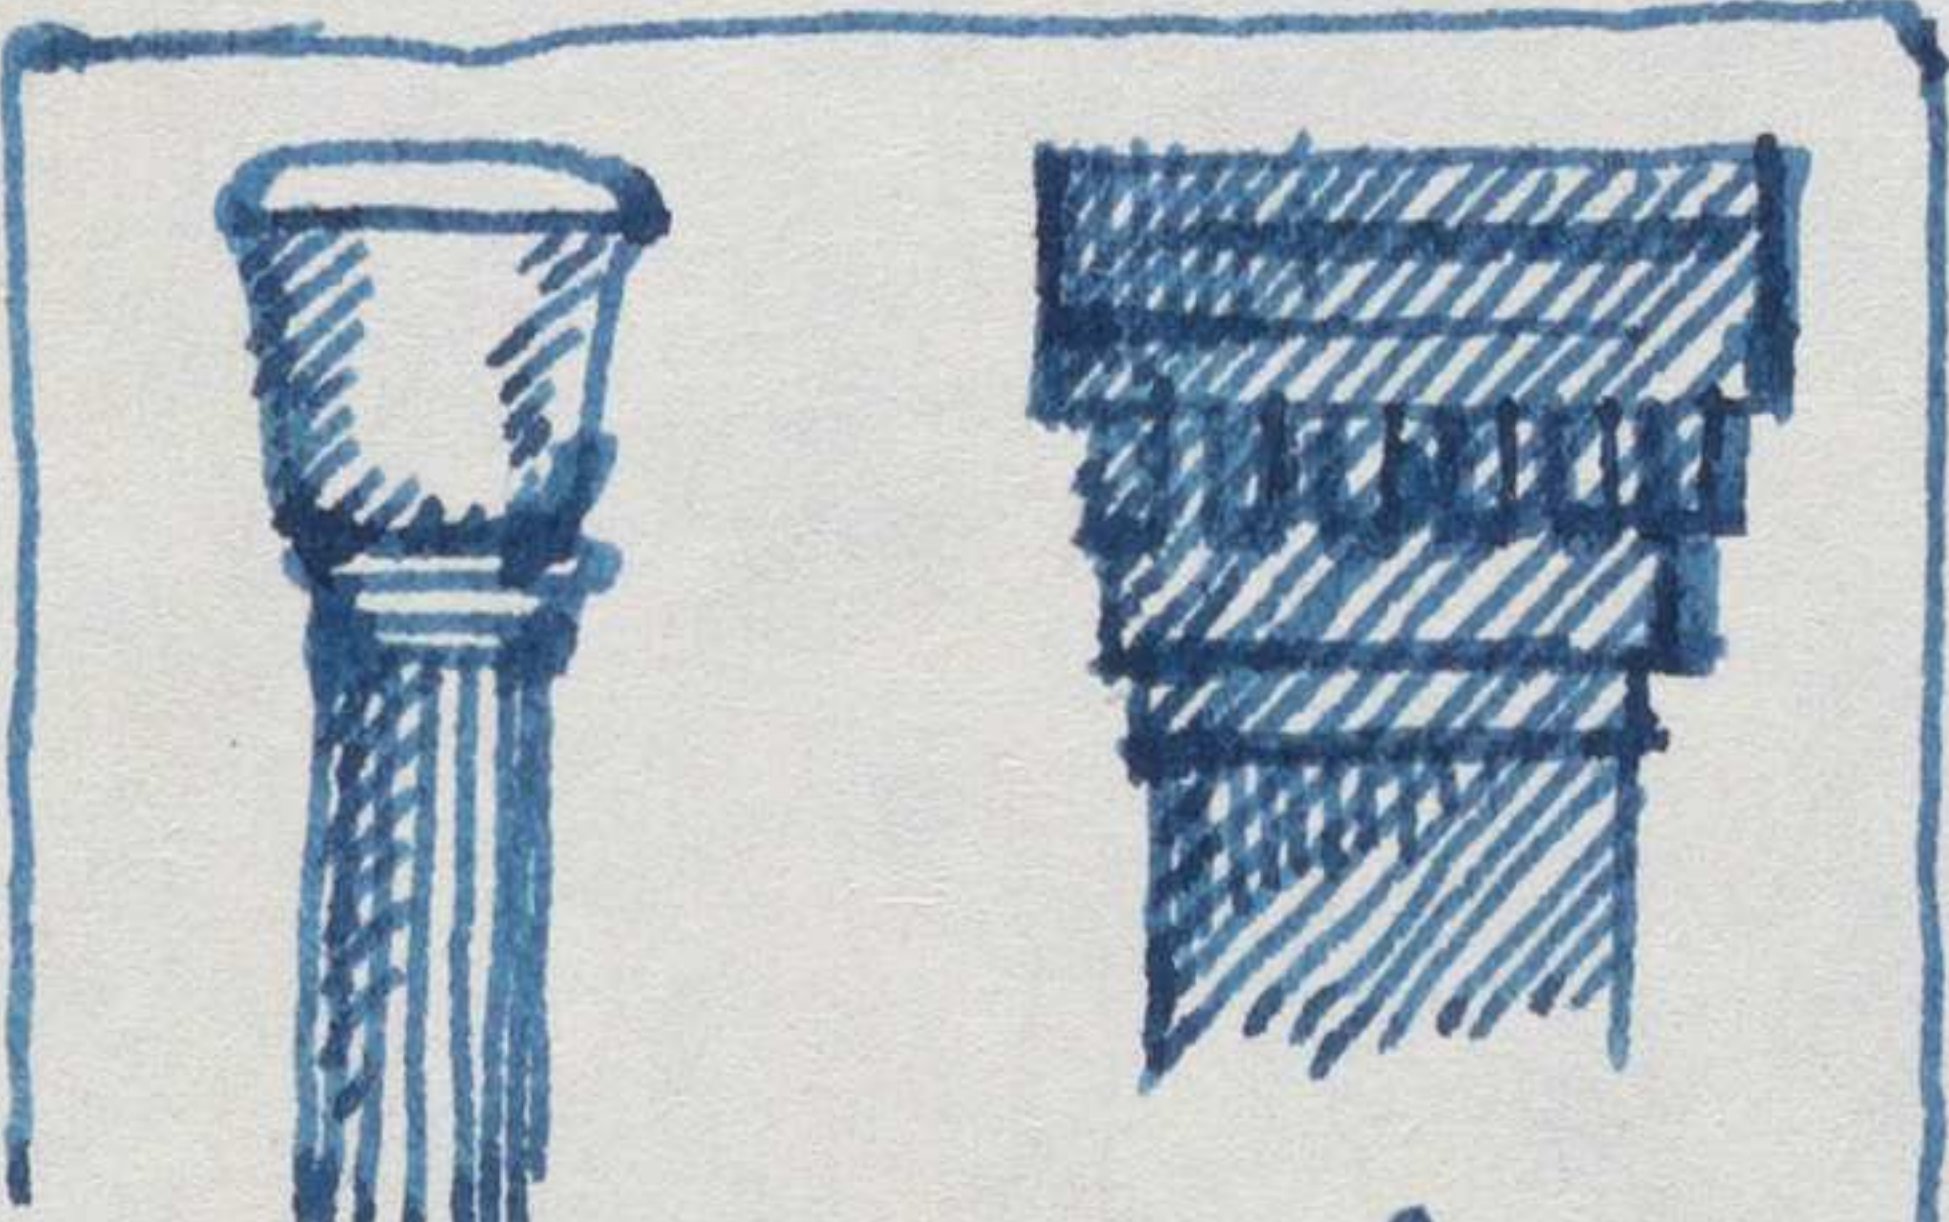
</div> <p><i>Two other interesting features are the lotus capiteled porch columns and the brick work in the two chimneys.</i></p> <p><i>porch cap. chimney</i></p>

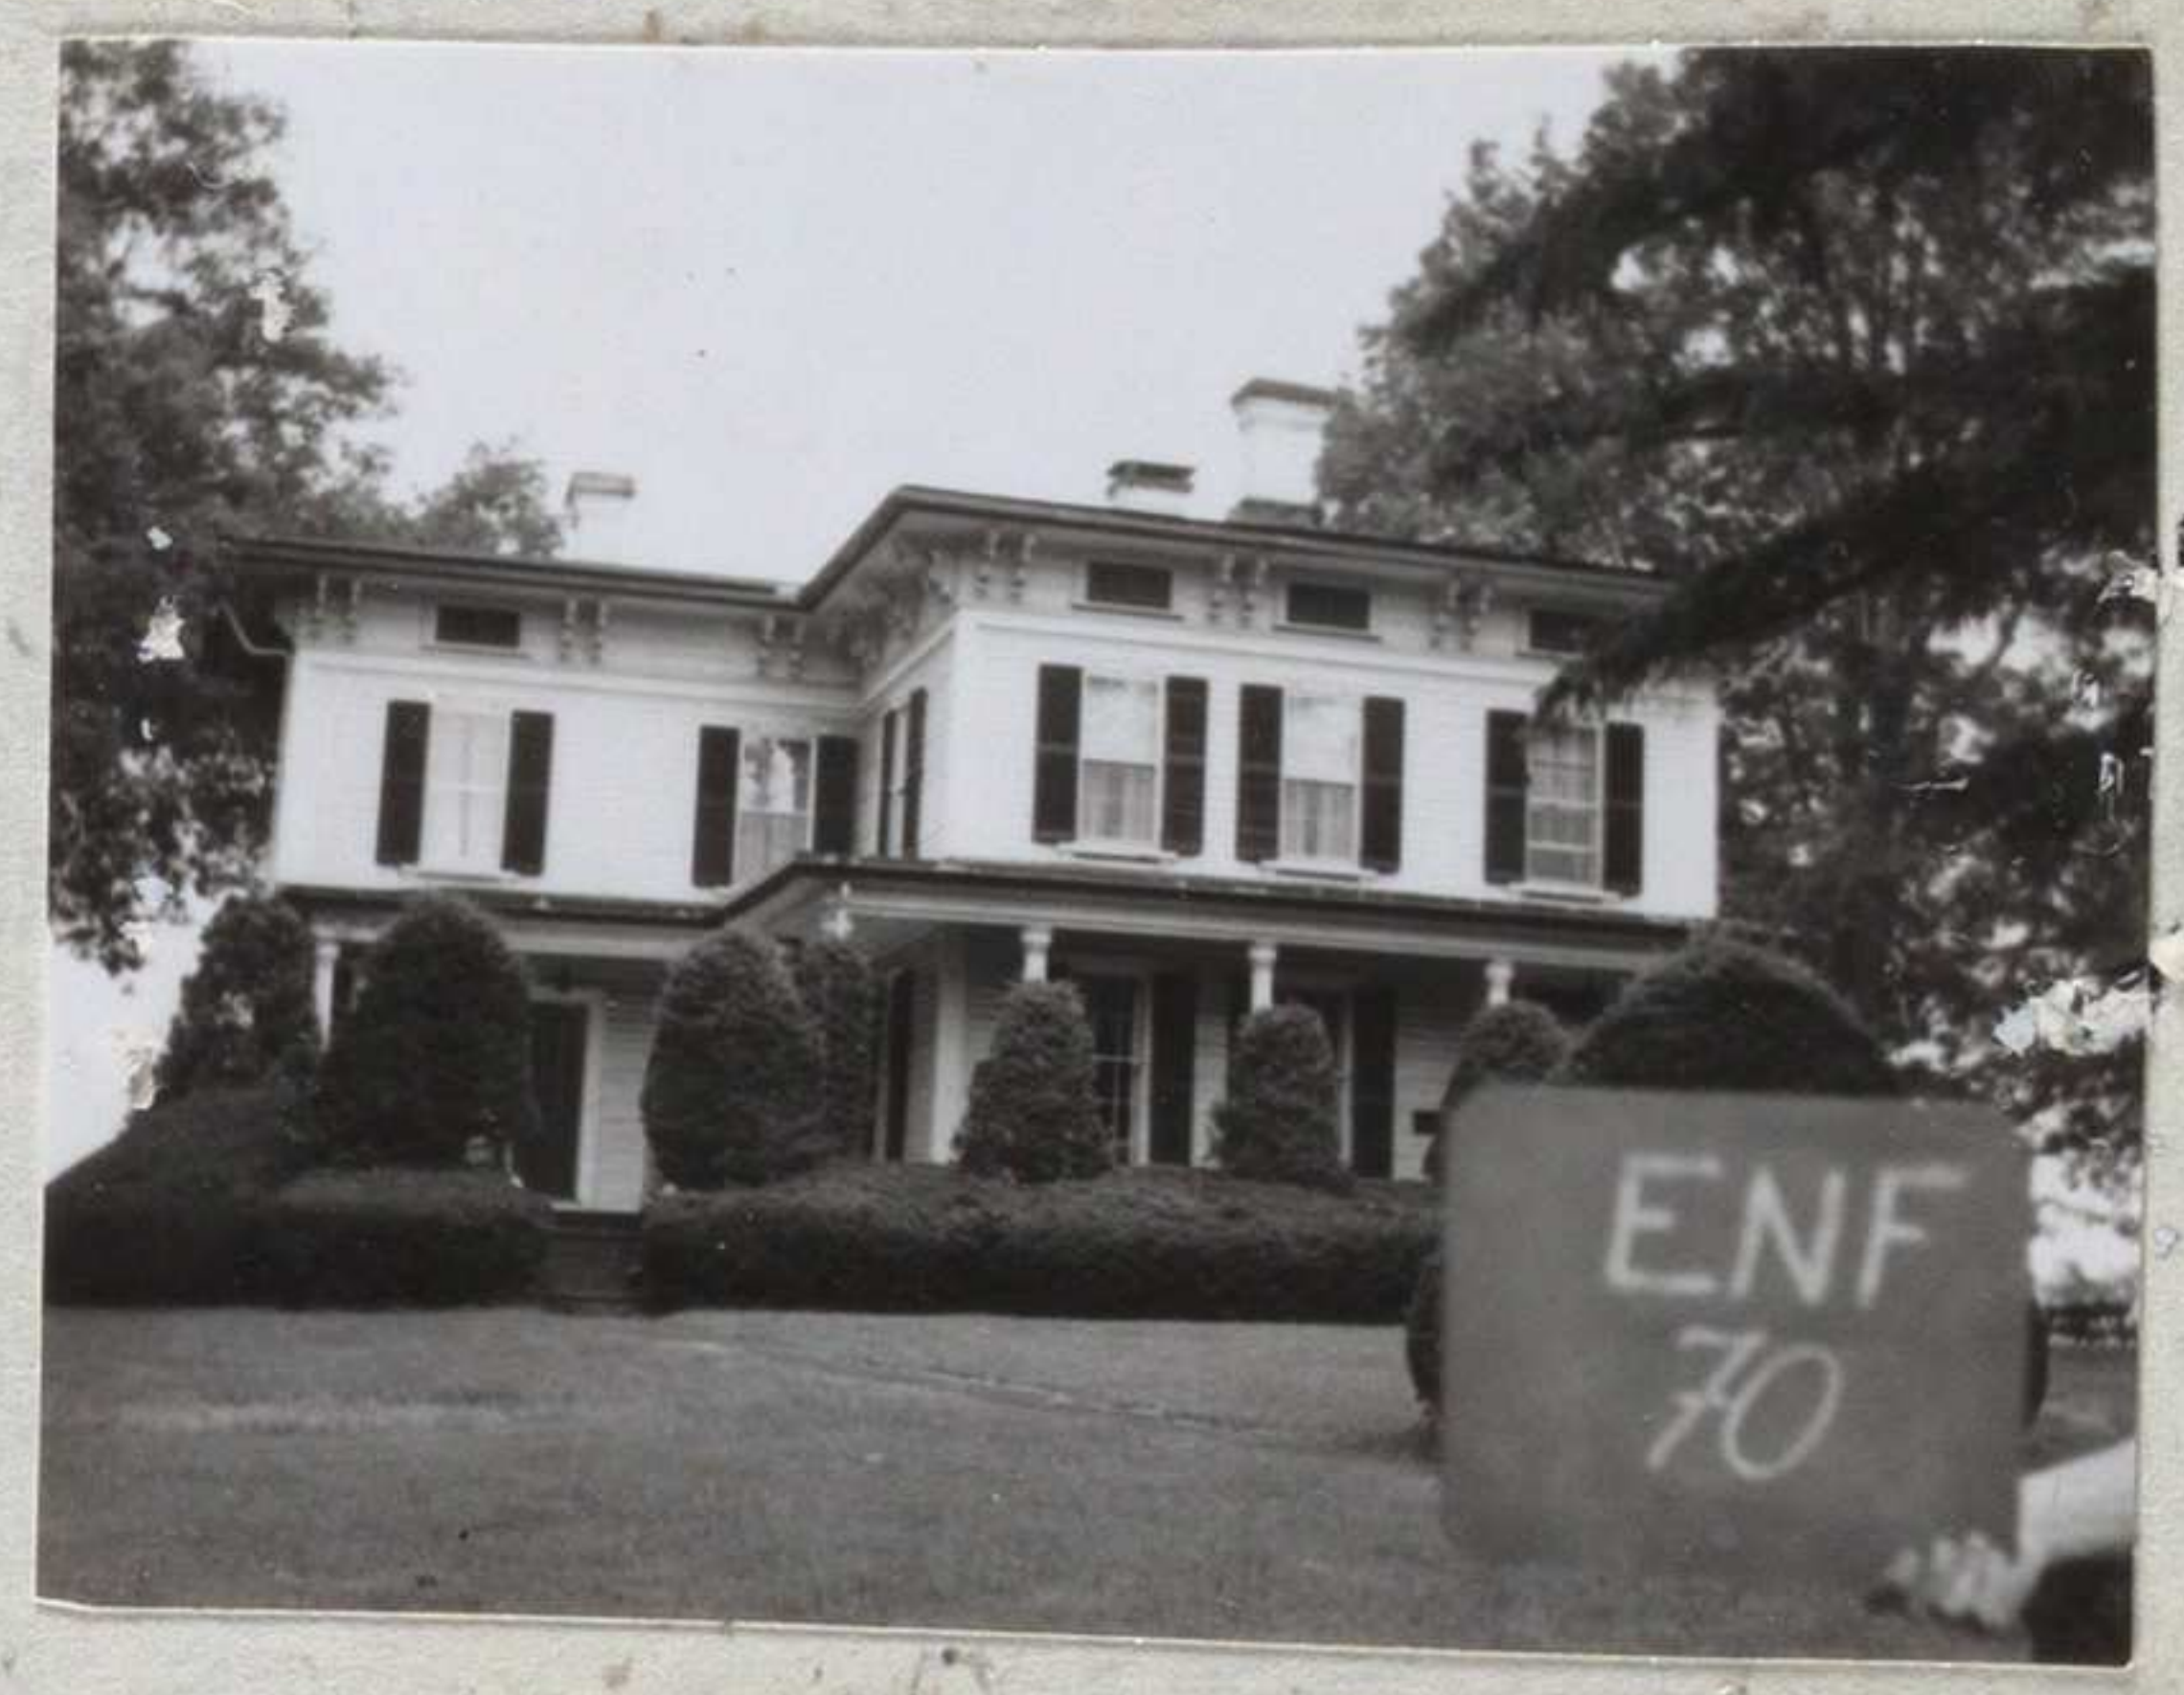
</div>	<p>7. PHOTOGRAPH <i>Enf 70</i></p> <div data-bbox="1504 1838 2035 2248">

<p>1. STATE <i>CT</i> COUNTY <i>Hartford</i> TOWN <i>Enfield</i> VICINITY STREET NO. <i>1290 Enfield Street</i> ORIGINAL OWNER <i>RIAL STRICKLAND</i> ORIGINAL USE <i>Residence</i> PRESENT OWNER <i>?</i> PRESENT USE <i>Residence</i> WALL CONSTRUCTION <i>clapboard</i> NO. OF STORIES <i>2 1/2 stories</i></p>	<p>HISTORIC AMERICAN BUILDINGS SURVEY INVENTORY</p> <p>2. NAME <i>Rial Strickland House</i> DATE OR PERIOD <i>1862</i> STYLE <i>Italian Villa style</i> ARCHITECT BUILDER</p> <p>3. FOR LIBRARY OF CONGRESS USE</p>
<p>4. NOTABLE FEATURES, HISTORICAL SIGNIFICANCE AND DESCRIPTION</p> <p style="text-align: right;">OPEN TO PUBLIC <i>No</i></p> <p><i>The ell shaped, 19th century house is built on a brownstone foundation. It is recognizable by the porch extending the first floor and the huge 6/6 window which extend to floor level on this first floor. The 1/2 windows of the third floor are shuttered, occurring between double brackets in the entablature. The front door with arched upper panels is framed in a transom and sidelights of cut glass.</i></p> <div data-bbox="298 1456 752 1739">

<p>5. PHYSICAL CONDITION OF STRUCTURE</p> <p>Endangered <i>No</i> Interior <i>Good</i> Exterior <i>Good</i></p> <div data-bbox="353 1908 1194 2276">
